Safety Bulletin

Machine controller's foot crushed in the wheels of a road rail vehicle

Ref: NRB 15/10

Location: Market Harborough

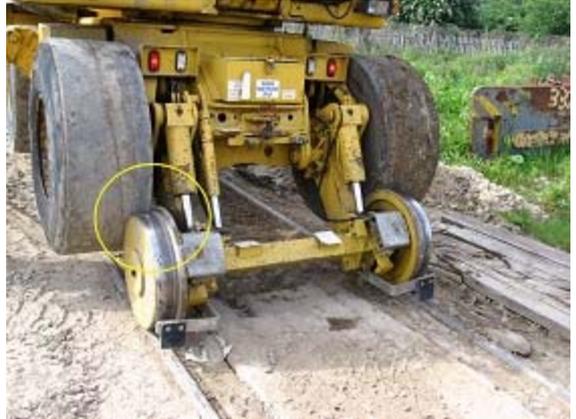
Mecalec 14 RRV with trapping point circled

As the machine moved the machine controller's foot was pulled into the trapping point between the road and rail wheels. This resulted in a portion of skin becoming removed from his foot and heavy bleeding. The machine controller was air lifted from site to hospital.

- Our most relevant life saving rule is: Never enter the agreed exclusion zone, unless directed to by the person in charge.
- How can machine controllers keep themselves safe by applying this lifesaving rule?
- How should this rule be applied when approaching a piece of plant?
- How do we plan and communicate plant exclusion zones that are fit for the specific sites we will be working at?
- How do we set up and maintain an effective exclusion zone around all types of plant?
- What difficulties may be experienced with these arrangements and what do we need to do to overcome these difficulties?
