No: IGS 290

Network Rail Safety Bulletin

LEVEL CROSSING SURFACE GAPS

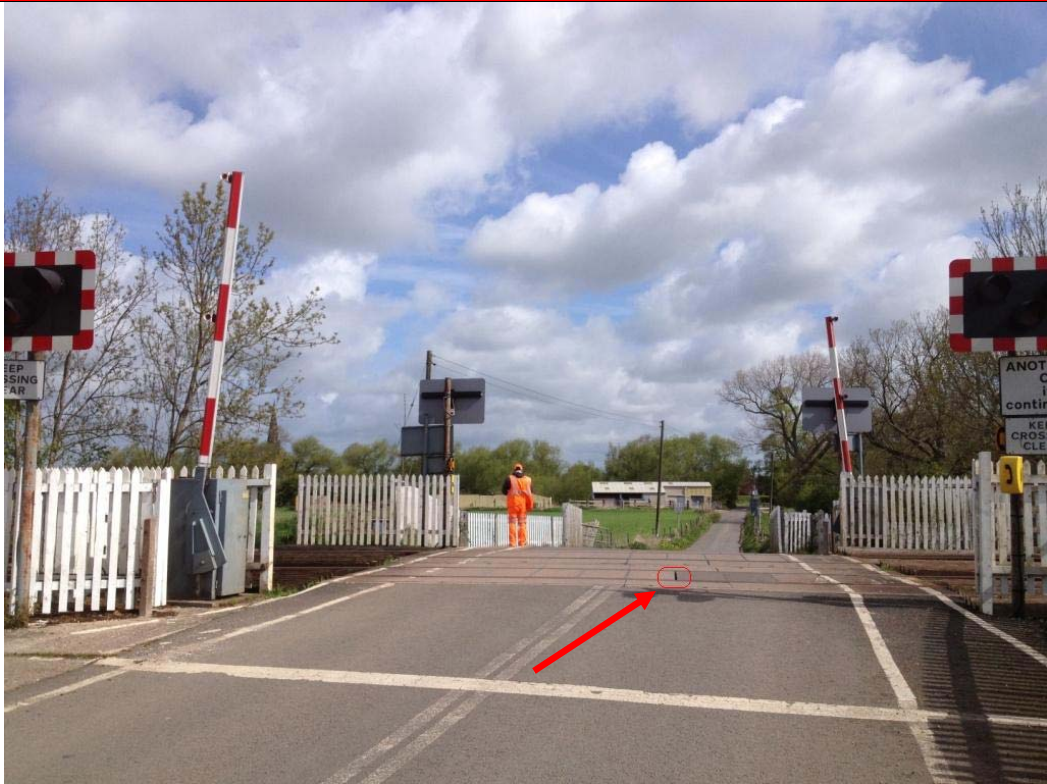
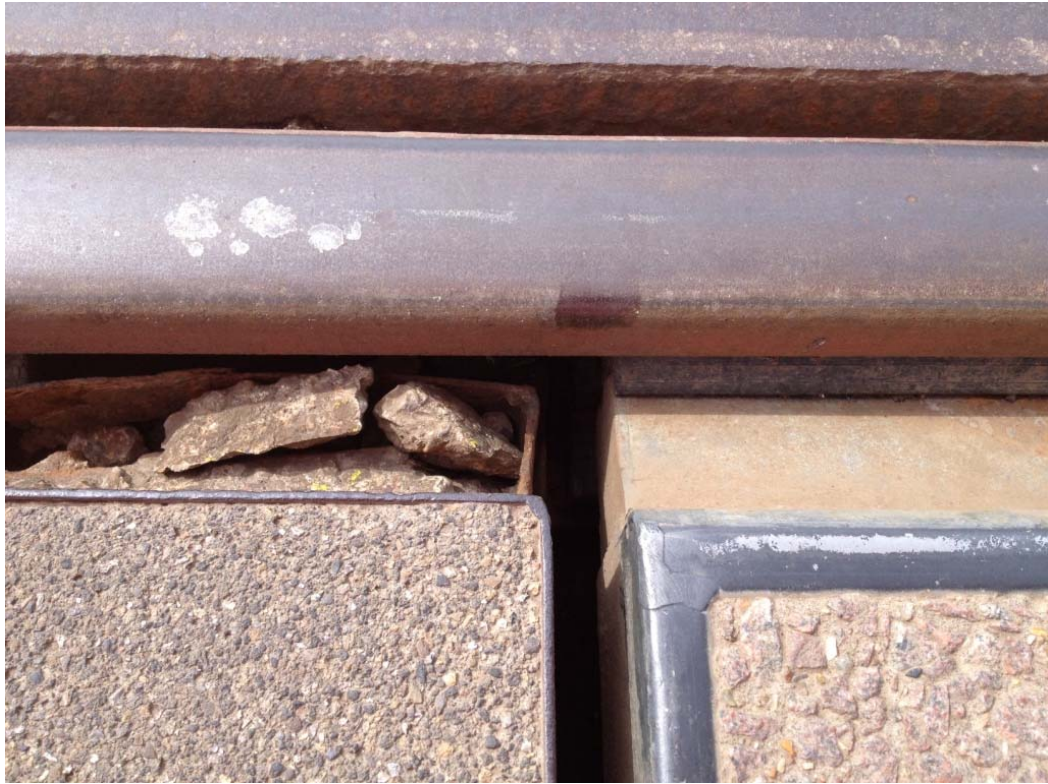
Earlier this year, a cyclist's front wheel fell into a gap in a level crossing surface at an automatic half barrier level crossing in East Midlands Route. The incident occurred while two Level Crossing Managers were on site. They stopped the road traffic, gave first aid and called an ambulance.

Below are images of the level crossing surface with a red arrow showing the location of the gap, and also a close up of the gap.

Please can all staff involved in level crossing surfaces fault any gaps and if appropriate not leave them unattended. You are our eyes and ears and key to preventing these events.
