No: IGS 301

Network Rail Safety Bulletin

Arthur Flury Single Rod Neutral Section Installations – Risk of uncontrolled release of Contact Wire tension

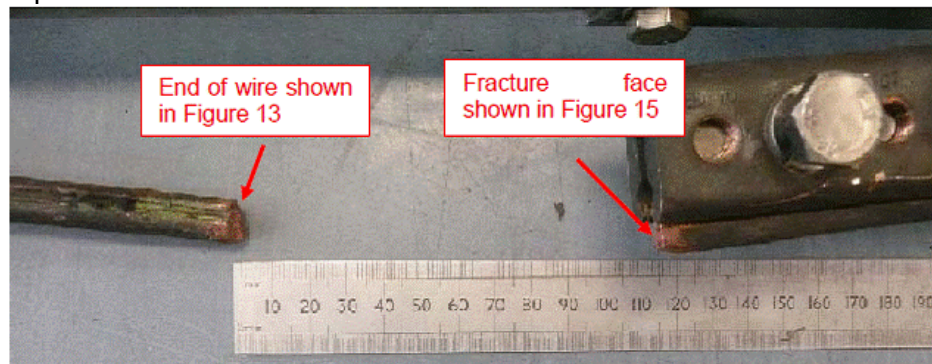
The primary cause of both dewirements has been determined to be a fatigue failure of the contact wire, with the initiation point being the top of the contact wire at the entry splice. Both neutral sections had been installed for approximately 2 years and were installed in 107mm² Hard Drawn Copper contact wire, with a line speed of 125mph.

Boroscope inspections of further neutral sections have found corrosion and signs of crack formation on other entry splices and LNE route are currently implementing a programme of mitigation measures to prevent further dewirements. The root cause of the fatigue failures is being investigated by LNE route, an independent investigator, the manufacturer and Energy Services.

Where any OLE works are being carried out at any Arthur Flury Single Rod Neutral Section location, a rig shall be installed across the Neutral Section assembly from contact wire to contact wire to mitigate against the risk of the wire parting and the uncontrolled release of tension.
