No: 0316

Network Rail Safety Bulletin

Failure of Iveco 5.5t RRV Front Rail Gear

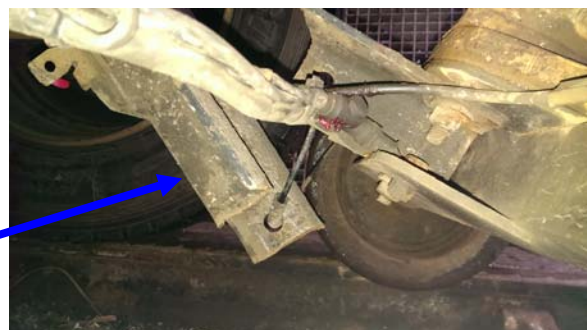
Whilst attempting to deploy the front rail gear of an Iveco 5.5t Road Rail Vehicle (RRV) when on tracking at the start of a shift, it became apparent that the axle would not align with the rails correctly. A subsequent inspection of the vehicle found that one of the rail gear arms that connect the rail axle to the vehicle body had broken in half. There were no injuries or damage to infrastructure, but this could have led to a derailment, posing a risk to the safety of the vehicle operators.

The failed front nearside arm that connects the rail axle to the vehicle chassis.

All Phase 1 Iveco 5.5t RRVs must not be used in rail mode until further notice. Phase 1 vehicles include those fitted with a flatbed body, with vehicle registration numbers starting FJ62, FN62 and KX62. Phase 1 vehicle use in road mode is still permitted.
