Safety Advice

Robel orbital hand tamper failure

Ref: NRA 16/03

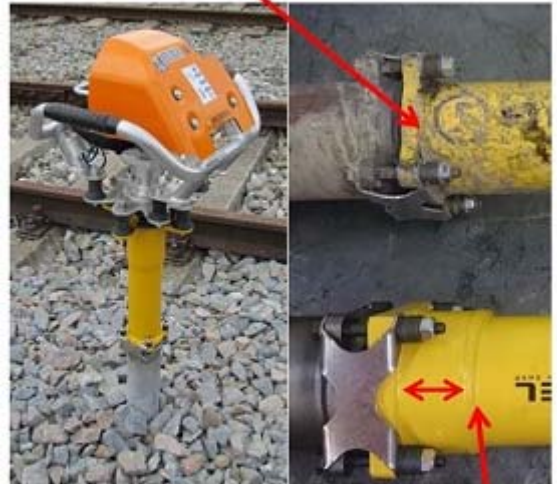
Figure 1 damaged weld (un-modified shaft)

This failure resulted in a wrist injury to the operator. Following investigation it has been identified that the weld around the base of the shaft had cracked resulting in a catastrophic failure of the weld.

The possibility of a future failure to unmodified equipment presents a significant risk to operator safety. Therefore all users and maintainers must quarantine all unmodified tampers (figure 1) immediately.

- All Robel 62.05 orbital tampers are to be inspected prior to their next use. The visual inspection should focus on the weld and flange areas of the shaft.
- Immediately quarantine all Robel 62.05 orbital tampers that are not fitted with the modified shaft (figure 1) and return them to the supplier pending modification.
- Robel 62.05 orbital tampers with a shaft modified with a reinforced collar (figure 2) and confirmed as undamaged may return to service.
