Safety Advice

Stanley TJ10 lifting jack - cracking

Ref: NRA 16/04

Date of issue: 22/04/2016

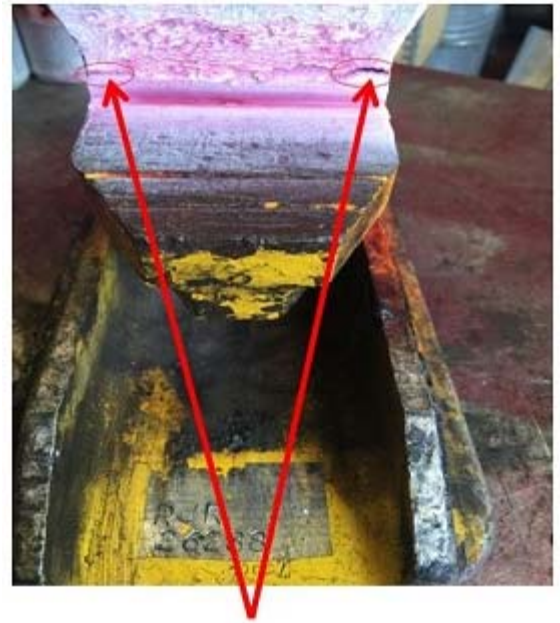
Cracking Points

During an inspection of a Stanley TJ10 lifting jack, cracking was identified approximately 5mm from the elbow at the foot of both sides of the lifting face. [Reference: NIR-Online (8250): NIR 3237 Initial Stanley TJ10 10T Hydraulic Rail Jack Defect]

Subsequent jacks were quarantined by the user with Dye Penetrant Non Destructive Testing (NDT) completed. This testing identified significant numbers of the named equipment as damaged due to cracking.

There is a risk that the damage identified could cause a catastrophic failure when lifting rail, causing severe injury to operators and personnel within the immediate area.

- All users and maintainers of the equipment must quarantine all Stanley TJ10 lifting jacks immediately.
- A competent fitter must complete Dye Penetrant NDT to identify any failure in the indicated area.
- All equipment that has crack indication faults should remain quarantined and be returned to the supplier for repair.
- Upon completion of Dye Penetrant NDT, equipment not identified as unserviceable can be returned to service.
