Safety Advice

Uncontrolled movement of Genie Z60 rail mounted MEWP (FR1326)

Ref: NRA 16/06

Date of issue: 11/05/2016

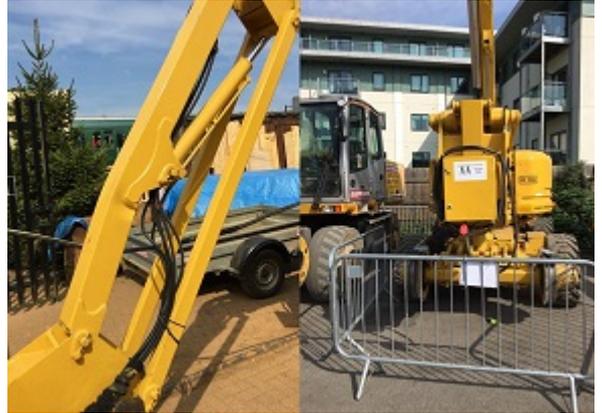
A Genie Z60 rail mounted MEWP (FR1326) rolled in an uncontrolled movement into a ballast box and RRV trailer.

In an attempt to re-set/reconfigure the MEWP it was taken out of rail mode. As the MEWP Operator lowered the rail wheels remotely from outside of the basket the brakes failed and the MEWP started to roll in an uncontrolled movement in the London direction.

As a result there was minor damage sustained to the ballast box and damage to the basket and arm of the MEWP.

Initial testing of the MEWP concerned was carried out by the Principal Contractor on Monday 9 May. Whilst the exact cause of the incident is not yet known. Network Rail has cause to believe that there is possibility of a brake override switch (for emergency recovery) having been operated which releases the machine brakes whilst activated.

- All Genie Z60 Rail Mounted MEWPs are IMMEDIATELY to be quarantined and subjected to a fleet check to ensure that the emergency override switch is correctly isolated.
- All Machine Operators and Machine Controllers MUST ensure that a full brake test is carried out as soon as the machine is subsequently on tracked in accordance with the Infrastructure Plant Manual NR/Plant/0200.
- Details of the machines quarantined and subsequently inspected are to be sent to Olufemi Okeya by clicking the link above. This shall include as a minimum:
 - 12 digit number;
 - EAC number and expiry date;
 - Converter name and contact number.
- An investigation is being carried out by the Principal Contractor and further action may be necessary once the outcome of the initial investigation is known.
