# Safety Advice

## Permaquip towing trolley tow pin security

Ref: NRA 17/12

Date of issue: 24/11/2017

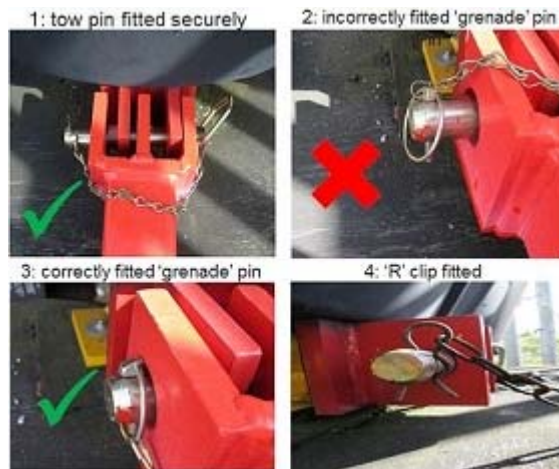
Tests undertaken jointly with RAIB on the Permaquip Trolley and Gator involved in the Trolley runaway incident ([Safety Bulletin NRB 17/11](#)) have identified a condition where the tow pin linchpin could be wrongly fitted and fall out. As a consequence, the main tow pin could also fall out and detach the tow bar.

The tow pins currently supplied are commercial tractor pins and are longer than necessary (see image 1). This enables the retaining linchpin (referred to as a grenade pin above) to be fitted incorrectly.

The linchpin has one flat side which must be fitted against the coupling. When the ring is closed over the linchpin, the ring must be held under spring tension against the linchpin as image 3 above.

Discussions are in progress regarding the replacement of these 'grenade' pins with 'R' Clips similar to image 4.

- Check the correct fitting and closure of any linchpin when working with trailers, personnel carriers or other on track plant with the same coupling.
- Quarantine any tow pins with missing chains or damaged linchpins.
- Report any of these defects via the close call system.
