## Derailment and collision at Watford Tunnel

**Ref:** NRB 16/16

**Date of issue:** 30/09/2016

**Location:** Watford Tunnel

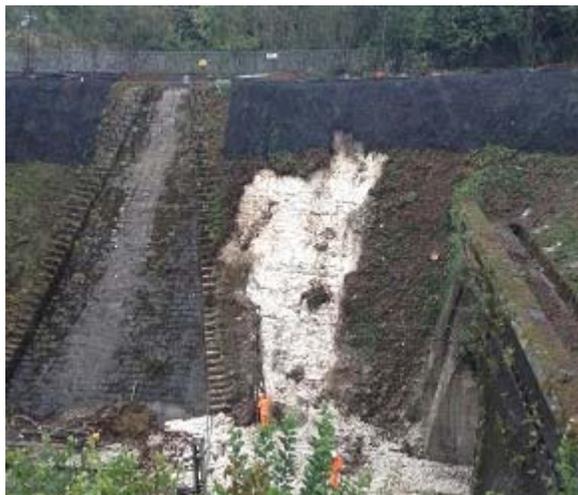
On 19 September 2016 a train struck a landslip at the entrance to Watford Tunnel. Coming to a stop in the tunnel the derailed train was then struck by a train travelling in the opposite direction before emergency protection could be put in place.

There had been a failure of the cutting caused by overtopping of the crest by surface water. Weathered chalk washed out from the face of the slope into the up cess and line adjacent to the northern portal of Watford Tunnel.

Vegetation had been removed from the cutting surface as part of work to mitigate the threat of rock-fall with rock netting.

- Do you understand the requirements for your role in Route adverse/extreme weather plans?
- Are the operational procedures for managing the risks posed by adverse/extreme weather events clearly understood and consistently applied?
- Is the presence and condition of crest drainage on the approach to tunnel portals understood?
- How are drainage assets identified in pre-construction information packs (PCIPs) for any project works you are involved with?
- Do pre-construction walk-outs identify unknown assets and check with those responsible what level of protection / access / maintenance would be required during construction activities?
- Are similar cutting slopes being worked on by contractors at the moment?
- Are Asset Protection teams proactively managing land use changes around high risk locations of our network (for example tunnel portal cuttings)?
