# Safety Bulletin

## **Overtuned Road Rail Vehicle (RRV)**

**Ref:** NRB 16/20

**Location:** Kingsbury Junction

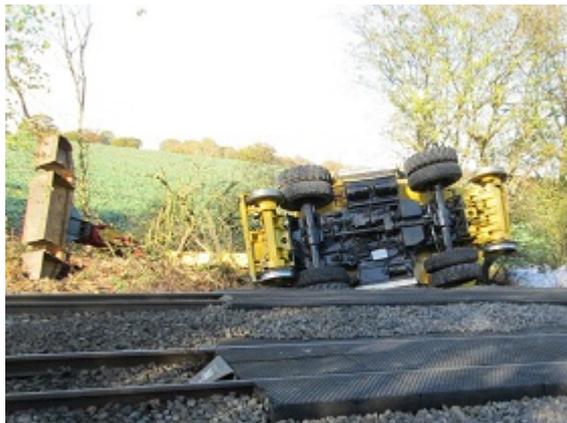
In the early hours of Friday 11 November a Liebherr A900 excavator working for Network Rail Maintenance at Kingsbury Junction derailed and overturned in the cess.

The machine was in rail mode and slewing around from end to end on a road rail access point (RRAP) in preparation to couple to a trailer. The track at the site had a 127mm cant, within the machine's certified capability for cant up to 150mm.

The boom was fitted with a wet bed bucket which was empty. Initial indications are that the machine was put in to an overload condition which caused it to derail and subsequently over turn. There were no staff injuries.

- How do we check that the required plans are in place before we start work and that those plans are adequate?
- How do we ensure that RRAPs are appropriate for the type of machine planned to be used?
- How do we select competent machine operators?
- How do we make sure operators know the correct set up, use and limitations of their RRV?
- What role do On-Track Plant Operations Scheme Representatives play in checking safe arrangements on site?
