Staff injured by OLE failure

Ref: NRB 17/01

Location: Shenfield Station, Essex

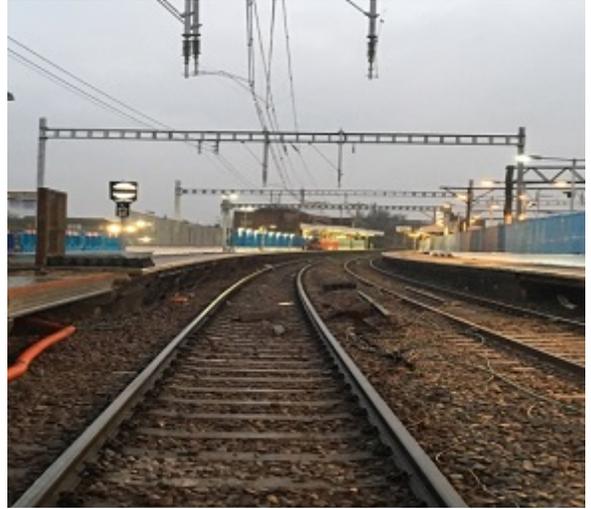
Whilst preparations were underway it appears that the existing OLE dropper suffered a failure causing the OLE to fall downward.

The existing radius of the wiring allowed the cables to straighten and move across from the Down Electric to the Up Electric causing it to swing sharply hitting two operatives working as part of the permanent way gang on the Up Electric. One of the operatives was reportedly knocked to the ground.

- When establishing exclusion zones around work how do you ensure they are sufficient to protect all staff including those in other teams in the work vicinity?
- For OLE works how are radial forces considered when deciding the size of the exclusion zone?
- How do you make sure that exclusion zones for your work are enforced and remain effective throughout the works?
