Safety Bulletin

Failure of a concrete service duct slab

Ref: NRB 16/10

Location: Overbridge at Crescent Road, Scotstounhill, Glasgow

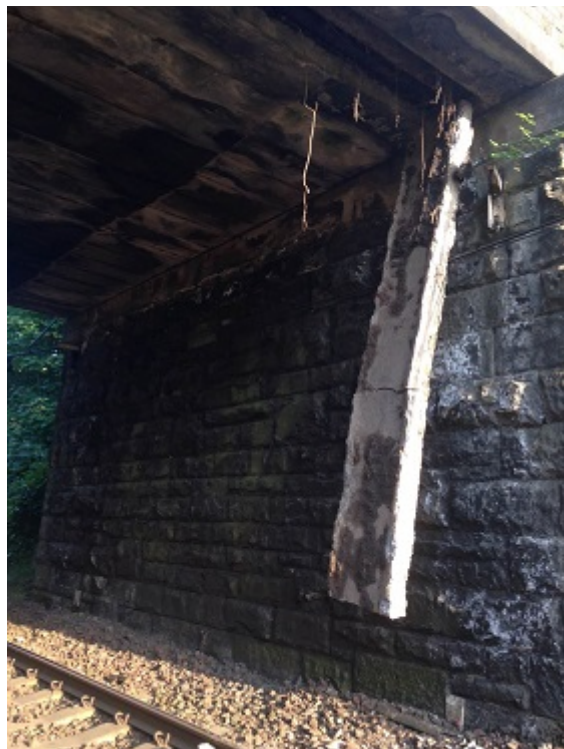
On the evening of 5 June 2016 a 7m x 0.4m x 0.1m thick section of reinforced concrete slab fell from the underside of overbridge 268/004 on the Hyndland East Junction to Dalmuir (via Yoker) Line in Glasgow.

The falling concrete damaged the OLE causing it to trip and the debris fouled both lines.

The in-situ cast slab spanned between two precast concrete beams in the bridge deck and formed the base of a service duct under one of the footways. The service duct contained a 6" gas main and a 4" water main.

Early indications are that the service duct slab was not constructed in accordance with the design and that the steel reinforcement in the slab did not extend into the nibs resting on the support beams.

A review of the most recent bridge examination reports has found that there was evidence that the service duct slab had dropped slightly however it appears likely that those involved in examining the bridge and evaluating the subsequent reports did not realise that the element was a transverse spanning secondary slab and believed it was a longitudinally spanning main girder therefore the severity of the defect may not have been recognised.

- Where are transverse spanning in-situ concrete service ducts most likely to be found in overbridges (under footways and verges)?
- What signs do you look for to differentiate between transverse spanning in-situ concrete slabs and longitudinally spanning precast concrete beams (e.g. poorer quality concrete finish, less distinct chamfers/joints, change in concrete finish from adjacent beams)?
- What records could be obtained to confirm construction details (e.g. assessment reports, record drawings, technical queries)?
