Shared Learning

A landslide at Harbury Cutting during remedial works

Ref: NRL 16/03

Location: Harbury Cutting, between Leamington Spa and Banbury

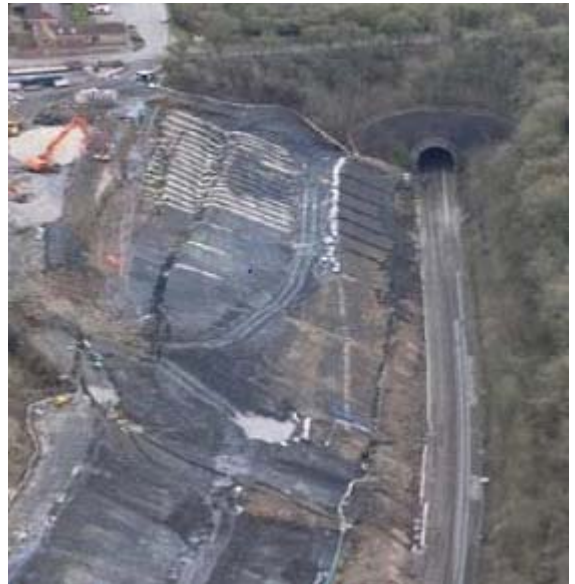
On 14 February 2014 during winter storms part of Harbury cutting in Warwickshire failed. The cutting landslide was approximately 30m deep and 100m in length.

Two weeks earlier work was underway to repair the slope at Harbury cutting on 31 January 2015 when a landslide occurred in the Blue Lias Formation consisting of bands of Shale and Limestone geology.

The slope failure was caused while excavating for construction of drainage trenches and to reduce the slope angle.

Slope stability analysis did not adequately take into account the history of failure in the cutting and the presence of low strength layers caused by previous cutting failures and geological features.

For very large, complex earthworks or earthworks with a history of ground movement there is a need to carry out sufficient site research, investigation and monitoring to meet the design and investigation requirements of Eurocode Geotechnical Category 3 (BS EN 1997-1).

Assurance should be more intrusive where there is greater project complexity or a history of ground movement.
