LESSONS LEARNT

Wagon Derailment at Hoo Junction Depot

CONTRACT : Depot Incident

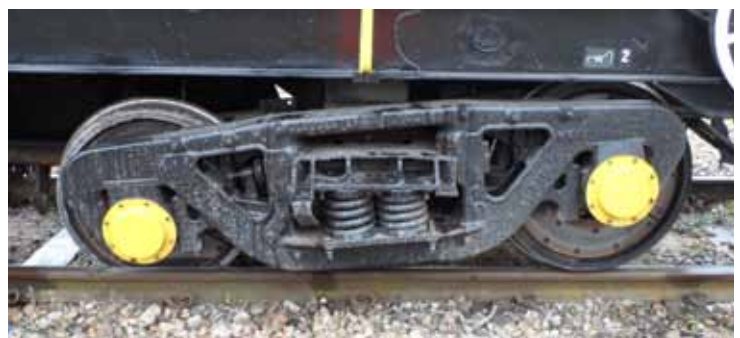
- On 6th November at 01:30hrs during a propelling movement undertaken by a DB Schenker, a loco hauling 18 wagons from the Staff Halt into Hoo yard sidings road No.3 a derailment occurred. The first 8 wagons to enter the sidings entered without any issues. The next 4 wagons derailed causing damage to the infrastructure and incurring substantial costs to the business of approximately £88,000.

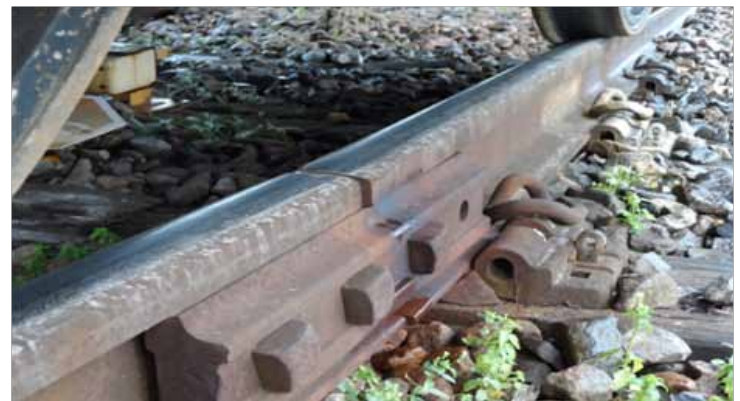
- Lack of maintenance to the sidings has led to poor track quality and a various track deficiencies.
 - decayed sleepers
 - non conforming joints
 - wide track gauge
 - bad top line
 - poor track formation
- Wagon number 17512 had an unevenly distributed load. This was the first wagon that derailed.

- Full Terms of Reference issued, investigation team appointed and Ill investigation well under way.
- All joints at the depot being inspected and any identified issues being resolved.
- All decaying sleepers being changed.
- Technical resource reviewing top line throughout the depot, kango packing is ongoing and will improve overall track quality.
