Safety Advice

No. 01/2015

The Crossrail Programme

Serious Eye Injury

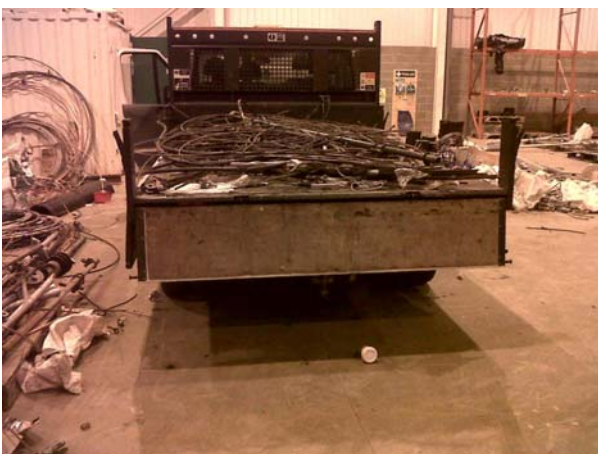
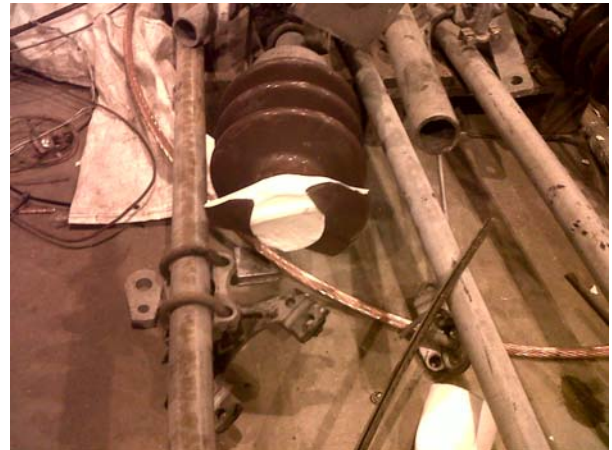
- Whilst unloading a vehicle inside Stockley depot on Tuesday 30th December, a porcelain insulator pot rolled from the flatbed falling to the ground and subsequently shattered. Fragments flew up and a shard went into the eye of a trainee OLE Lineman standing nearby.
- He was taken to hospital by ambulance and later transferred to a specialist eye unit where he received emergency surgery. Sadly, he has permanently lost the sight in his left eye.
- It is believed that Safety Glasses were being worn at the time of the accident.
- A full investigation is ongoing by the Principal Contractor.

- All activities must be properly planned, managed and documented.
- Ensure all tasks have been suitably risk assessed and **task specific PPE** is being worn.
- A Task Briefing Sheet (TBS) must cover the actual task being undertaken with specific risks and mitigations.
- Adequate levels of supervision must be maintained at all times.
- Good housekeeping and material storage must be maintained at all times.
- Waste management plans must be in place with the necessary contingency arrangements to ensure there is a sufficient quantity of skips available.
- The risks associated with the handling of insulator pots must be considered.
