3<sup>rd</sup> June 2014

No: NRS 327

## Network Rail Safety Bulletin

### Fall from height from HGV

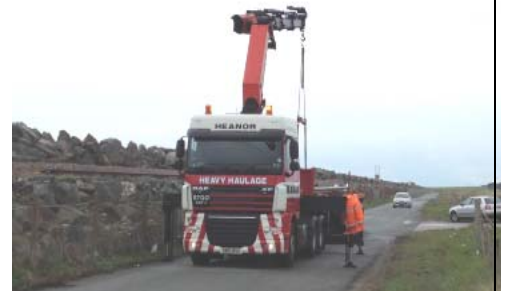
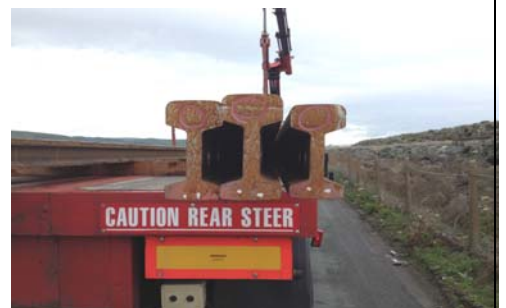
The HGV was loaded with each rail touching the next. To enable cam locks to be placed around the rail head for unloading, the operator had to access the trailer via ladder and bar the rails apart manually.

While moving the rail, the bar slipped and the operator fell off the trailer onto the ground.

- Always have a suitable risk assessment in place before commencing any activity
- Always use equipment for working at heights that is fit for purpose
- Unless it is clear other protection is in place, never work at height without a safety harness
