LNW/Sc Route

ENGINEERING & SAFETY BULLETIN No. 10 Re Issue 14/1/2014

Date of Event	27/03/2013
Location	Wolverhampton
Event	Track Circuit Failures
Details

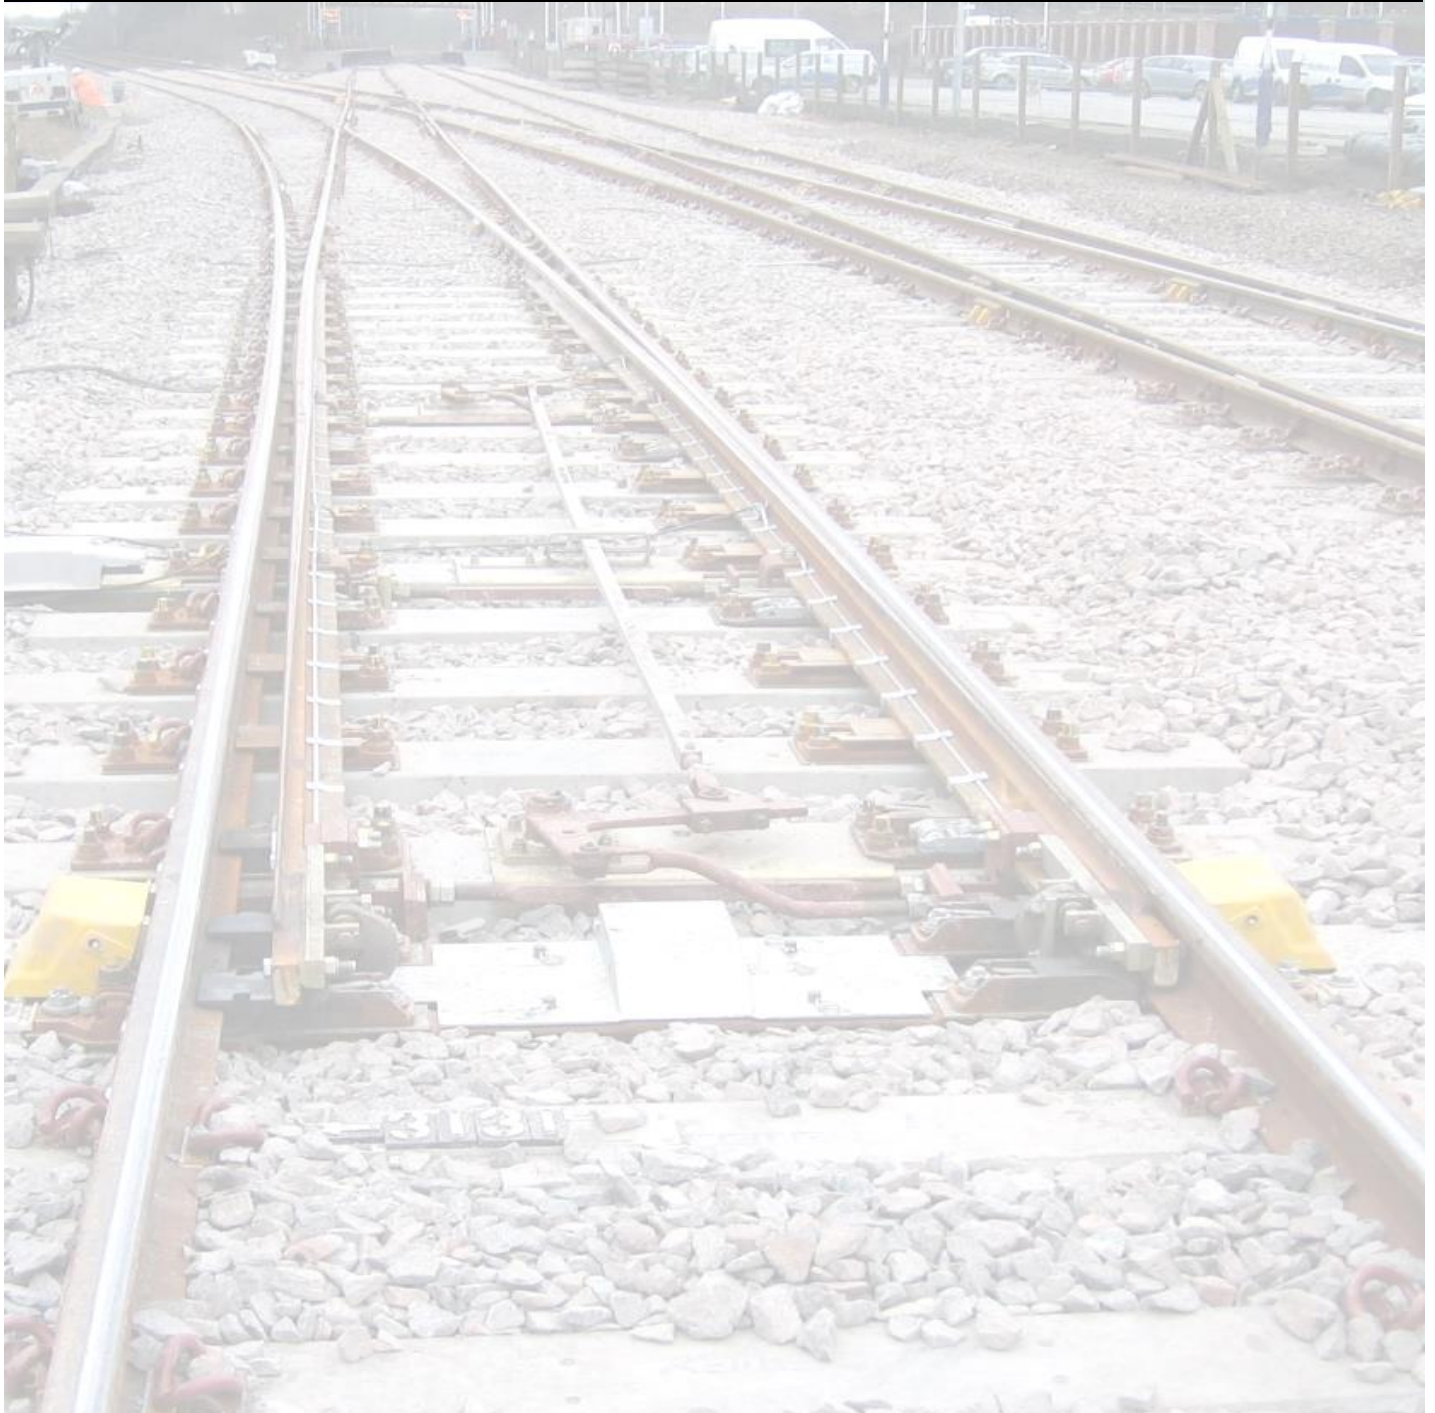
An incident occurred at Wolverhampton where, Rocksalt was used on and around the track as a de-icer in readiness for this weekend's S&C works at Crane Street, Wolverhampton.

The Rocksalt has had the effect of causing **track circuit failures** in the area and has resulted in circa 1800+ train delay minutes as of 14:00hrs on 27/3/13.

Conclusion: **Never use Rocksalt** (or substances containing sodium chloride) on or around the track or track components.

Only use approved products as contained within the Network Rail Winter Consumables Catalogue, Issue 3, 2013. Please ensure that you read the limitations of each product as some are not suitable for S&C.
