No: NRS 294 - Issue 1

## Network Rail Safety Bulletin

### Wrong-side failure of track circuits due to rust on the rail head

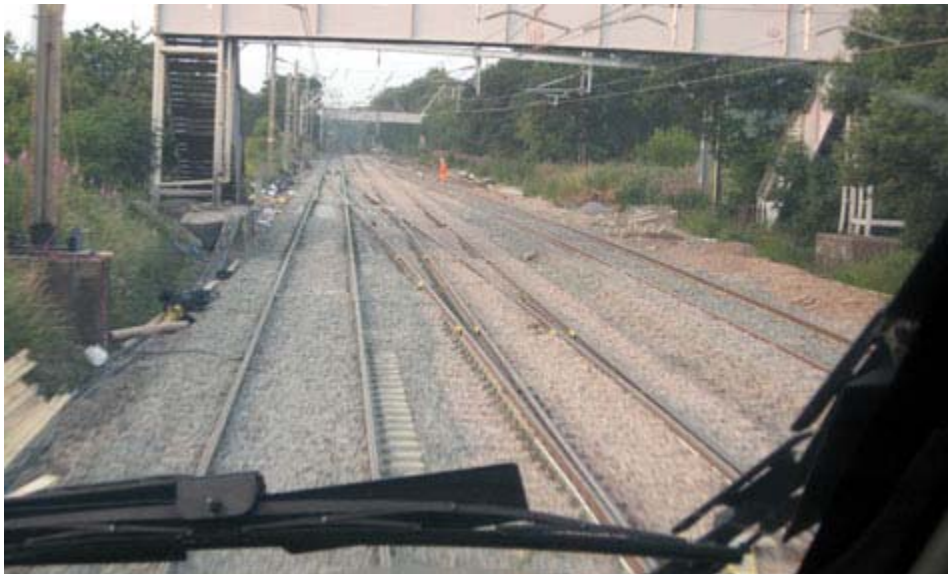
Its purpose is to alert railway staff of the need to advise the signaller when rail is brought into use for train running and could be rusty, whether due to installation of new rail, or where traffic has not operated over a line for a period of time.

If you are the signalling tester responsible for bringing new or out of use rail into use in a track circuited area, you must advise the signaller that there may be rust on the rail head, specifying the affected area.

Before newly installed or out of use rail that has a visible coating of rust on the rail head as per the photograph is brought into use for train running, the responsible signalling tester must notify the signaller of the extent of the rail being brought into use. This can be either the track circuit(s) affected or the signals/points outside the affected area, making clear to the signaller the possibility of rusty rails preventing the track circuits showing occupied.

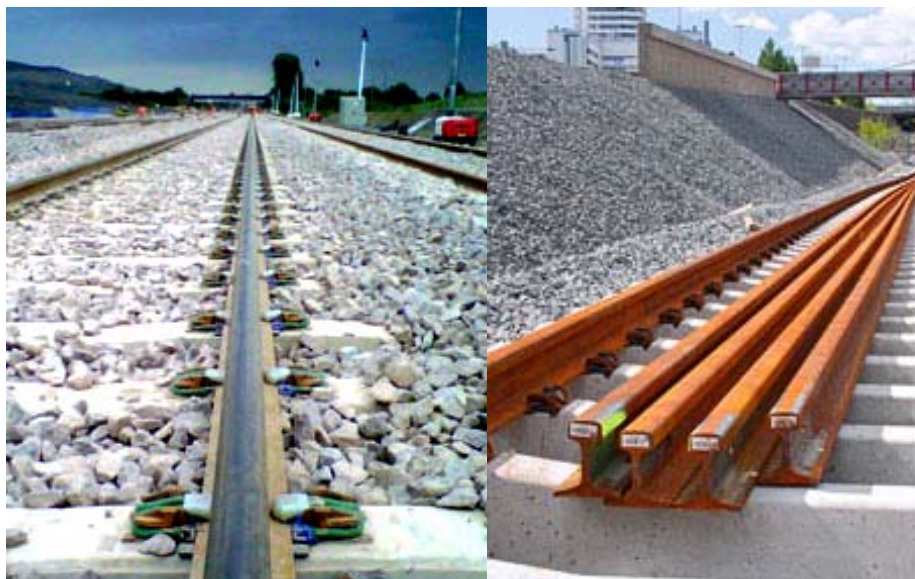
Well used rail provides a good conductive surface for track circuits, whilst rust on unused rails does not.
