No: NRS 294 - Issue 1

Network Rail Safety Bulletin

Wrong-side failure of track circuits due to rust on the rail head

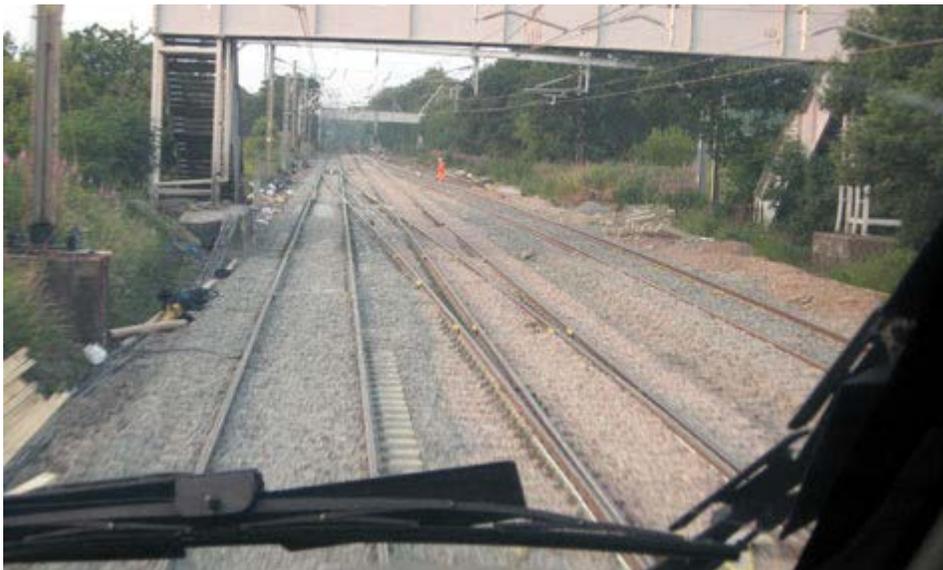
Its purpose is to alert railway staff of the need to advise the signaller when rail is brought into use for train running and could be rusty, whether due to installation of new rail, or where traffic has not operated over a line for a period of time.

If you are the signalling tester responsible for bringing new or out of use rail into use in a track circuited area, you must advise the signaller that there may be rust on the rail head, specifying the affected area.

Before newly installed or out of use rail that has a visible coating of rust on the rail head as per the photograph is brought into use for train running, the responsible signalling tester must notify the signaller of the extent of the rail being brought into use. This can be either the track circuit(s) affected or the signals/points outside the affected area, making clear to the signaller the possibility of rusty rails preventing the track circuits showing occupied.

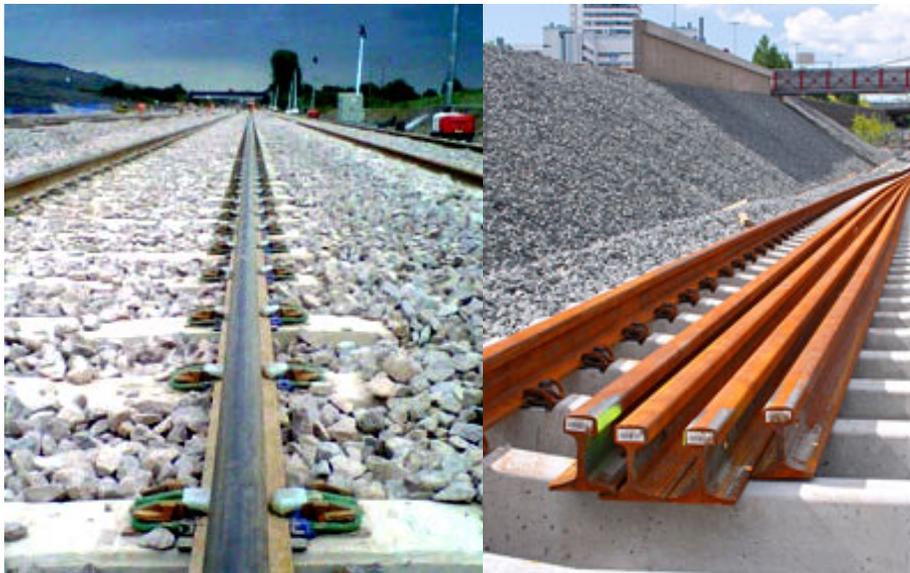
Well used rail provides a good conductive surface for track circuits, whilst rust on unused rails does not.
