No: NRS 318

Network Rail Safety Bulletin

TF25 Bogie Wheelset Lift Bracket Detachment

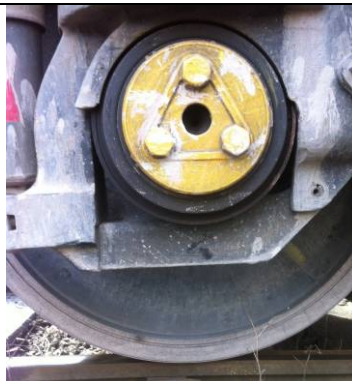
Bracket in place

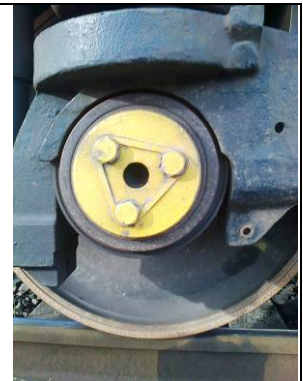
An additional wagon belonging to Network Rail has now been found to have the wheelset lift bracket missing during VIBT examination at Westbury. This latest incident is therefore unexplained.

Bracket missing

Extra vigilance is required at pre departure/train preparation examination looking for any indication that the wheelset lift bracket is missing, has detached or partially detached at either end. Any defective vehicle must be removed from the train unless competent dispensation is given by the vehicle owner's Engineer, the maintainer or maintenance control.
