No: NRS 339

**Network Rail Safety Bulletin**  
**Emergency Stop Circuits on SRS 18t Road/Rail MEWP's**  
**For the attention of all Operators of Network Rail owned SRS 18t**  
**Road/Rail MEWPs**

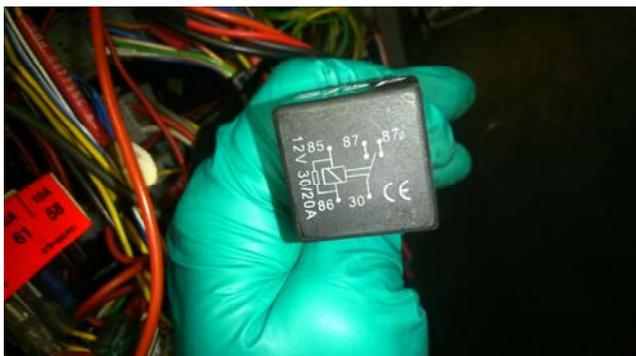
Initial investigations suggest the wiring modification may have been carried out by a road servicing company to rectify a brake fault, without full knowledge of the impact the modification will have had on the operational capability of the plant aspect of the vehicle. The modification had also put a 12v relay in a 24v circuit with the potential to overheat and cause fire damage.

**12v Relay**

- Inspection of the wiring arrangements underneath the dashboard to identify if any modifications have been carried out (see pictures below).
- A full functional test of the emergency stop circuits to ensure they are all functioning correctly, this test must be conducted in **RAIL** mode. This should also be a normal part of the daily operator checks.
- Any vehicles that fail the Emergency Stop functional test should be removed from service, quarantined and arrangements made to return the vehicle to the maintainer.

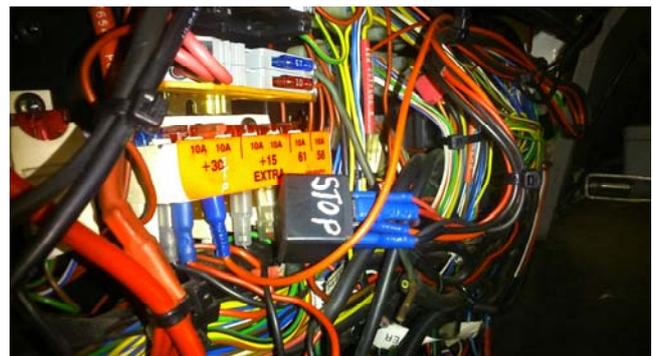
Following a recent fault on an SRS 18t MEWP it has been identified that an unapproved wiring modification had been carried out to effect a repair. This repair has inadvertently bypassed the emergency stop circuit rendering the emergency stop buttons totally ineffective, with the potential to import serious risk to those working on or around these vehicles.

**Modified Wiring Underneath Dashboard**
