No: NRS 328

Network Rail Safety Bulletin

Post Driver Plant and Attachments

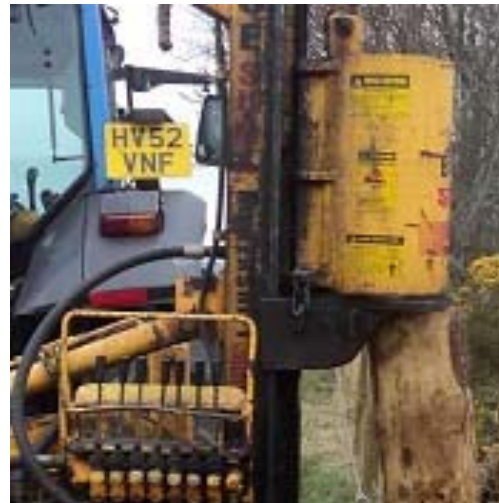
Whilst installing a line of fencing posts the Injured Person tripped on vegetation, instinctively putting his hand out to stabilize himself on the adjacent post. In doing this he inadvertently placed his other hand on the control levers which activated the hammer, crushing his hand between the strike plate and the post.

Bryce Suma PROF1 Post Kocker

- **Immediate prohibition** on the use of the Bryce Suma PROF1 Post Driver and all other variants with inadequate control or hammer guarding. Written confirmation of compliance with this instruction to be submitted to chris.browne@networkrail.co.uk from all sub contractors forthwith.
- 100% check of 'Post Driver' variants to confirm they don't pose similar risks and are compliant with the **Provision and Use of Work Equipment Regulations (PUWER)**. Record of visits to be maintained including photographs and plant record details.
- All equipment must be fitted with sufficient guarding or safety systems to limit accidental operation.
- All equipment must be fully maintained and inspected prior to use (giving particular attention to guarding, safety labels and validity of maintenance dates).
- All equipment must be CE marked .
