# Safety Advice

## Electric shock from Bussmann CamMaster fuse carrier, CM32F, rated at 32A

**Ref:** NRA 16/11

**Location:** Oxford Parkway

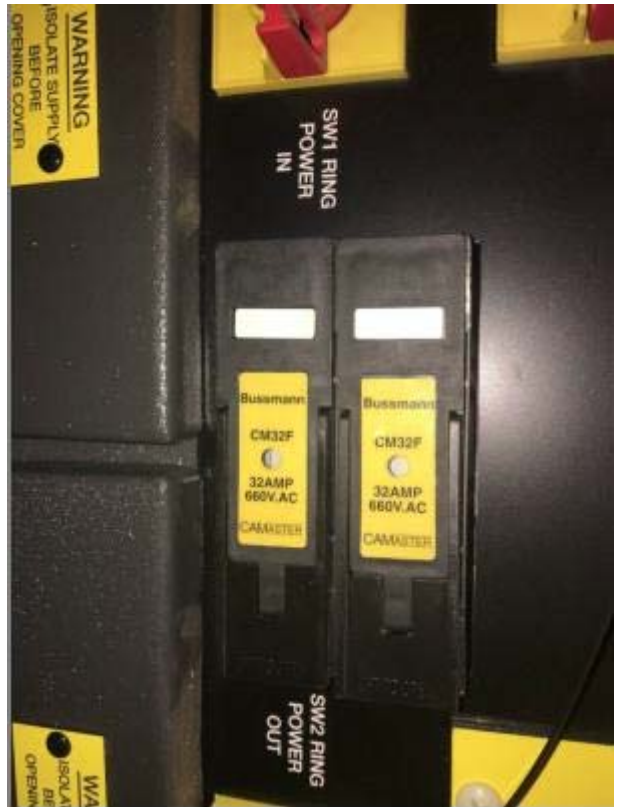
A member of contractor staff supporting electrical testing of the signalling power distribution system received an electric shock from touching a Bussmann CamMaster fuse carrier in a lineside location case / Functional Supply Point (FSP).

Subsequent testing revealed that the fuse carrier had an elevated voltage of up to 300V on its surface.

Under normal operating conditions no voltage should be present. Insulation breakdown in the faulty fuse carrier caused the elevated voltage.

Touching one of these 32A fuse carriers (part reference CM32F) cannot be assumed to be safe when it is energised.

- Every member of staff must test the surface of a Bussmann CamMaster fuse before touching or removing the fuse carrier from the base.

- The special requirements in NR/SPS S002 (the Authority to Work Live process) must be used if touching or removing the fuse carrier when energised. Working live should be avoided wherever possible.
