Engineering work site given up whilst track remained obstructed

Ref: NRB 17/09

Location: Kirkham South Junction, LNW Route

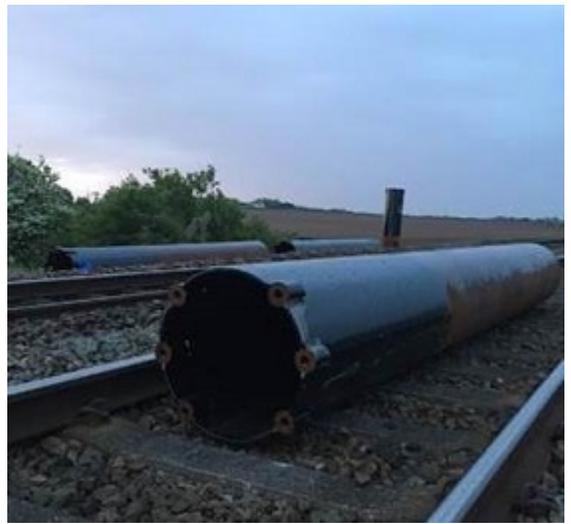
At 05:25 on 15 May 2017 a tamper, travelling at 15 mph transiting to exit the possession safely stopped short of a 5 metre long pile which was obstructing the Down Main line.

The pile, had been loaded into the Movax piling head and taken to the planned work location. On arrival the work group identified a pile "stored ready" on the lineside and set the pile they had been carrying down in the four foot of the opposite line a short distance from the place of work, and then proceeded to install the stored pile.

So the work group installed the pile to a safe depth and travelled back to the access point approximately 20 minutes away. No-one on-site remembered to collect the pile which had been set down in the four foot.

- How do we plan our work to make sure those delivering it for us have the time and resources to do so safely?
- How can a work group make sure that items temporarily stored on the track are removed to a safe location before they leave the place of work?
- What impact could applying the principles of Safe Work Leader / Person in Charge have on incidents like this?
- How long should an Engineering work site realistically be and what would make it too long or too short?
