Staff walking in close proximity to live OLE contact wire

Ref: NRB 18/02

Location: Crewe

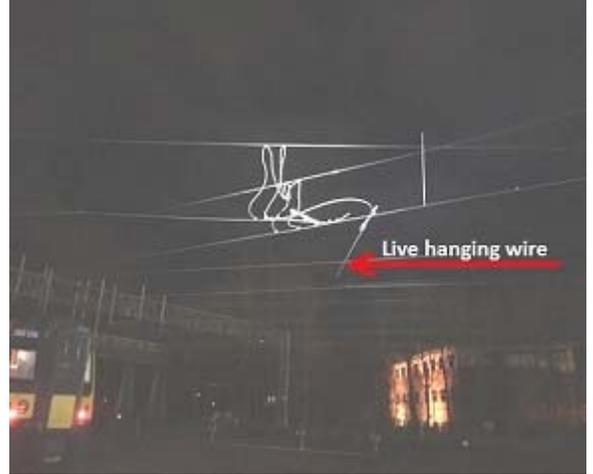
The overhead line contact wire parted as an electric train passed causing damage to the train's pantograph and resulting in the contact wire hanging down.

When overhead line staff arrived they found that staff had been walking in close proximity to the live contact wire that was hanging down. An emergency switch off had not been requested.

The parted contact wire is believed to have been within 30cm of head height and staff had walked beneath it. In September 2014, less than 25 miles away, a train driver suffered extensive electrical burns in very similar circumstances when they left the cab after the overhead line had been damaged.

- Who should you contact if you believe the overhead line equipment (OLE) may be damaged?
- What precautions must be in place before you can approach but not touch OLE?
- What precautions must be in place before you can touch OLE?
- What other circumstances might increase the risk of injury when attending OLE incidents?
- What are the additional risks during the hours of darkness (or in a tunnel)?
