# Safety Bulletin

## **On Track Plant overturned during tandem lift**

**Ref:** NRB 18/15

**Location:** Market Harborough

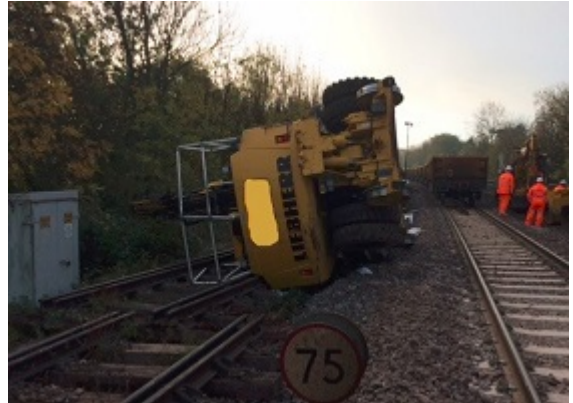
On 22 October 2018 at approximately 03:00 on an Infrastructure Projects site near Market Harborough, a Road Rail Vehicle Excavator Crane overturned whilst tandem lifting concrete sleeper track panels.

- How do we confirm that Lift Planners have planned lifting activities using the correct Duty Charts or planning tools for the specific On Track Plant (OTP) being used?
- How are Lift Planners provided with and able to confirm the dimensions of the load that is to be lifted?
- Practically, how do Machine Controllers confirm that OTP is operating in the correct configuration as detailed in the Lift Plans?
- How do Machine Controllers confirm that OTP is operating in the correct mode when tandem lifting and that Rate Capacity Indicator (RCI) is switched on and functioning correctly?
- How do the Machine Controller and Plant Operations Scheme (POS) Rep confirm the OTP is the equipment identified on the Lift Plans?
