Safety Bulletin

Fall from height off a hire vehicle

Ref: NRB 16/05

Location: Hessle Road, Hull

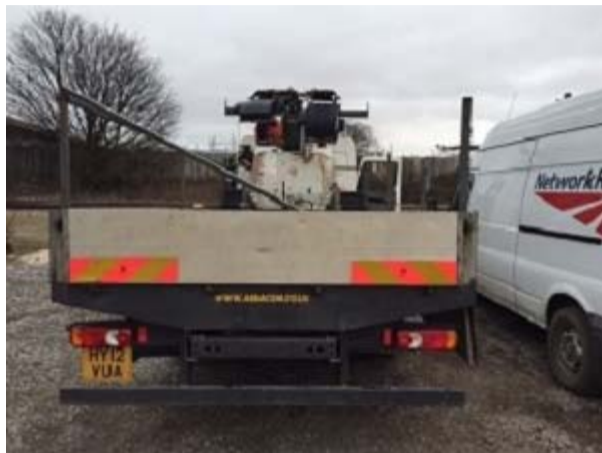
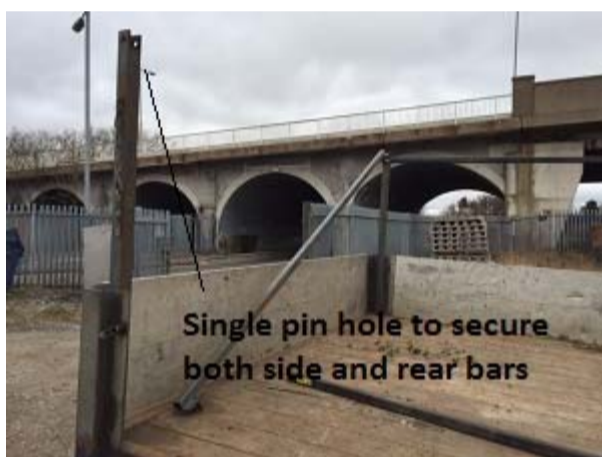
The vehicle drop side and right side hand rail had been removed to enable loading of the materials.

The staff member had moved to the rear of the vehicle and as they leaned themselves against the rear vehicle hand rail it suddenly gave way resulting in them falling backwards, landing on the tarmac and injuring their head.

- Initial findings indicate this vehicle hand-rail design differs from Network Rail HGV vehicles. There is only one securing pin that when in place on the post secures both the side and rear vehicle handrails.

- How do you familiarise yourselves with hired vehicles and any differences that may exist from any usual vehicle?
- What instructions or information do staff receive from hire companies on vehicle set-up?
- Where work at height may be required what actions must we each take to try and avoid it?
- Are vehicle hand rails suitable to be used for body support?
