Safety Alert

Slade Green electrical incident

Ref: NRX20-06

Date: 13/07/2020

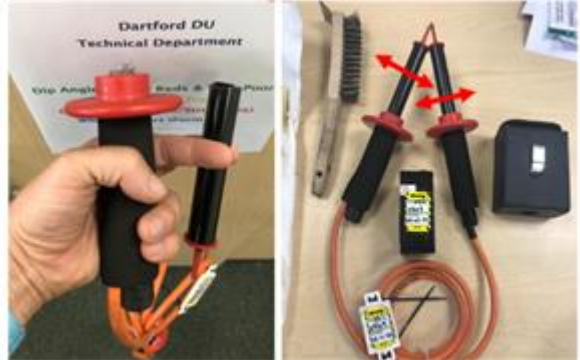
We have now identified that the Live Line Indicator used on site was defective, as it had side to side movement on one of the probes. The probes should be solid, and no movement should be detectable.

- Before you use a Live Line Indicator check there is no detectable movement on either probe.
- To do this hold the handle and gently try to move each probe in the direction indicated by the arrows above.
- If any movement is present STOP, quarantine the unit and use an alternative Live Line Indicator.
