No: 0316

Network Rail Safety Bulletin

Failure of Iveco 5.5t RRV Front Rail Gear

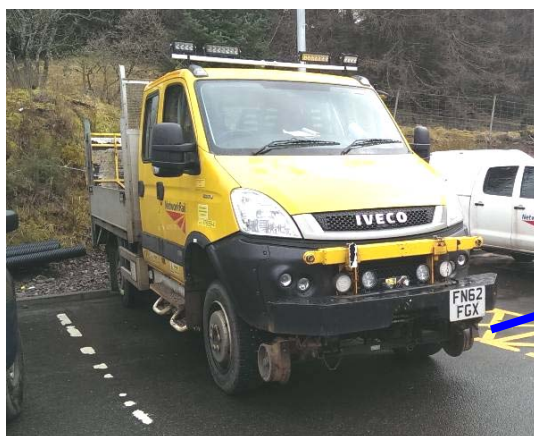
Example of 'Phase 1' Iveco 5.5t RRV with flatbed.

All Phase 1 Iveco 5.5t RRVs must not be used in rail mode until further notice. Phase 1 vehicles include those fitted with a flatbed body, with vehicle registration numbers starting FJ62, FN62 and KX62. Phase 1 vehicle use in road mode is still permitted.
