Safety Advice

No. 01/2014

The Crossrail Programme

Train / Trolley Collision

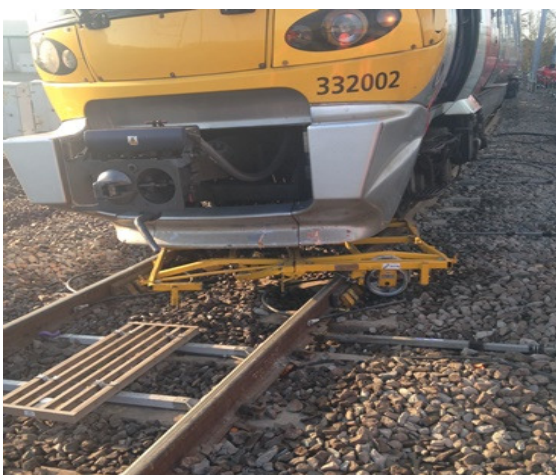
- At approx. 09:55 on Sunday 28th December, 1Y40 0948 Heathrow to Paddington struck and ran over a track trolley on the Up Airport Line at Stockley.
- No task briefing for activity to be undertaken.
- The trolley had been placed on a line open to traffic at line speed.
- The two man gang who were with the trolley managed to move clear and were uninjured.
- The gang had accessed the line after removing a demarcation fence without the COSS being present.

Trolley under train

- Only ever use an authorised access point.
- Always ensure that you understand the worksite limits.
- Ensure task briefing covers all activities to be undertaken.
- Always ensure you have a clear understanding of which lines are open to traffic.
- Clarify with your COSS any information you are unsure of.
- NEVER interfere or remove a safety barrier.
- Do not access the track or start work on the track without your COSS being present.
