No: IGS 319

## Network Rail Safety Bulletin

### Electric Shock to an Employee at Hamilton Square Station, Merseyrail, Liverpool

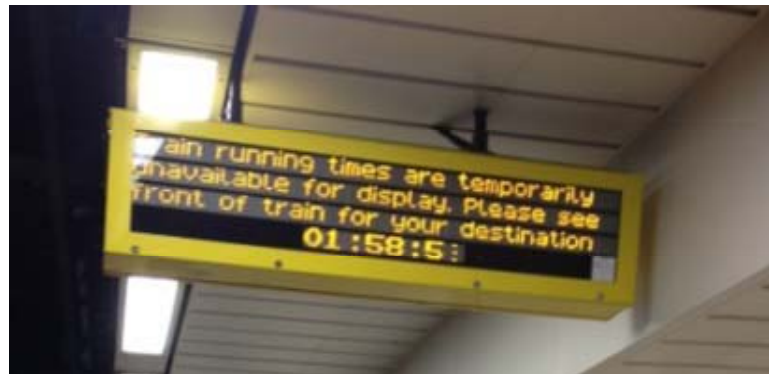
**Background:** On the 27<sup>th</sup> February 2014 at Hamilton Square Station, Merseyrail, Liverpool, an employee of Network Rail received an electric shock whilst working on a telecom customer information system fitting (CIS), as per the photograph below.

The injured person had isolated what should have been the mains input cable (the live leg of the mains input) by removing a fuse, and then tested for live electrics before touching the equipment. However the polarity of the cable from a line filter unit was reversed for electrical flow and the injured person received an electric shock from the equipment (240V AC) due to incorrect wiring during installation. A subsequent examination of the CIS unit revealed it had been wired incorrectly (reverse wired), and several others in the immediate vicinity (Hamilton Station) were found to be in a similar state and corrected.

- Relevant staff to be briefed regarding the Life Saving Rules.
- All relevant staff to ensure mains supplies are isolated, to test all wires for live current and to conduct a test to earth before touching. Relevant staff should not rely on the removal of fuses or testing of the live leg only.
- All relevant staff who fault/inspect CIS units to be made aware of this incident, and the remedial actions and control measures required.
- An investigation has commenced and the findings will be issued in due course
