# Engineering Alert

**Title of Alert:****Testing, Inspection and Use of Insulated Hand Tools (IHT)****Target Audience:**

5<sup>th</sup> Sep 2017

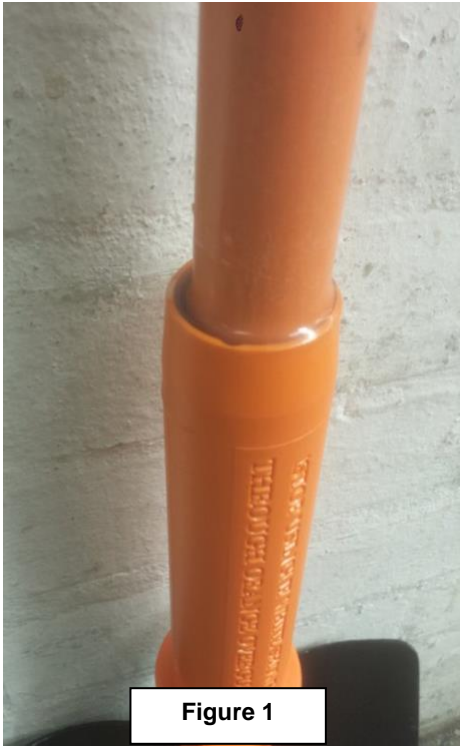
Figure 1

- Solid resin bond (figure 1) must be in place to stop water/moisture ingress at the top and bottom of the overguard, a soft silicon or missing seal does not meet the required standard (figures 2, 3 & 4).

- IHT deemed to have a soft silicon seal or a missing resin bond at the top and bottom of the overguard shall be withdrawn from service.
- IHT shall be inspected for correct markings as identified above or in BS8020:2011. Any tools that do not have the markings as indicated above or where markings are indecipherable shall be withdrawn from service, examined and retesting if necessary.
