Trespass causes severe electric shock to member of public

Ref: NRB 17/04

Location: Whitelees Road, Lanark

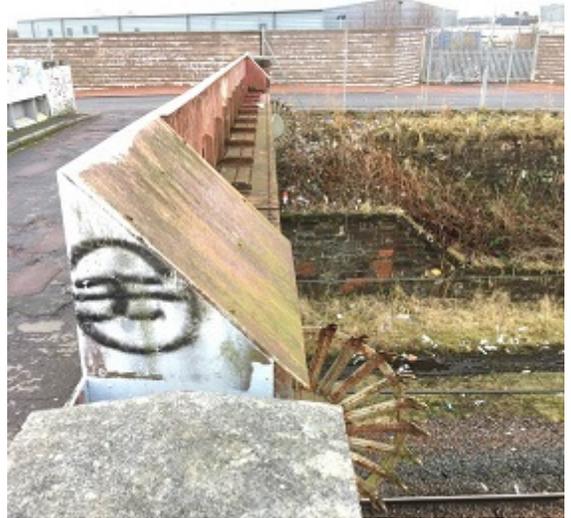
On 8 December 2016 a member of the public came into contact with the live overhead line equipment after climbing over the parapet of overbridge 033/006 at Whitelees Road in Lanark.

It is apparent that the male came into contact with the OHLE after slipping from the ledge on the outside of the parapet girder, subsequently causing his leg to make contact.

- If you find evidence of trespass and vandalism within the railway boundary how should you report this?
- What would you do if you saw a trespasser on the railway, or anti-social behaviour, near the boundary?
- When risk assessing lineside security, or when we receive reports of trespass, what do we do to understand the risks at the location?
- How could you help communicate the dangers of the railway to local communities?
- How can you propose improvements to prevent access at a structure?
- How do we consider potential weaknesses in security at bridges?
- What immediate action do you think could be taken to reduce the chances of access over the parapet and furthermore what long term mitigation should be considered (curved/sloped surfaces, spikes, etc)?
